# Richmond Refinery LPS Bulletin-Reliability

## Alky-Acid Line Leak

(9/11/2011)

**IMPACT ERM**  
**Loss ID# 21570**

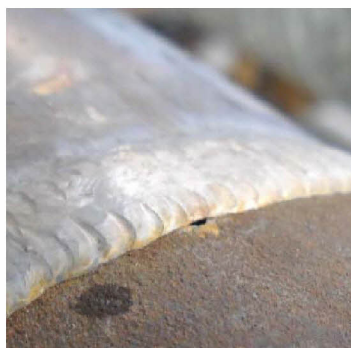
Pinhole leak at bimetallic weld as a result of hydrogen grooving

On September 11, 2011, during end of shift rounds, an Operator in the Alky plant discovered a pinhole leak on the fresh acid transfer line from the acid wash drum V-1440. The area was roped off and feed was pulled from the Alky plant so the line could be isolated for inspection and repairs. The leak was found on a bimetallic weld as a result of Hydrogen Grooving due to sulfuric acid at specific velocities. A temporary repair was made using a composite wrap and the unit was started back up on September 12.

However, on September 23, the composite wrap failed and feed was pulled from the unit to stop the leak. The line was again repaired using a composite wrap and started back up on September 24, where the newly installed composite wrap leaked immediately upon startup. The unit was shutdown again and all composite wraps were completely removed from the piping. A new composite wrap was installed with plans to install an engineered composite wrap the following week. The unit was started up without incident on September 26 and the engineered wrap was installed on the line in early October with no additional leaks. The line was upgraded to Alloy 20 in January 2012 as a result of this incident.

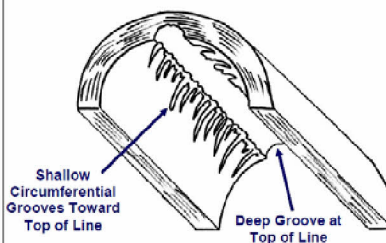
Chevron Engineering Standards-  
Fig. 3500-11- Drawing of Hydrogen  
Grooving Corrosion of Carbon Steel

- 2) Verify that the inspection techniques for the particular area are adequate for finding potential corrosion mechanisms such as hydrogen grooving. Note: Hydrogen grooving occurs only on the top section of the pipe and is generally very difficult to find without performing grid UT inspection on the piping.
